EAF Mobile Facilities (Ile Shima Island)

QHR205

(please note: This is a MALS-36 MF CSC failure, beyond Repair capability.)

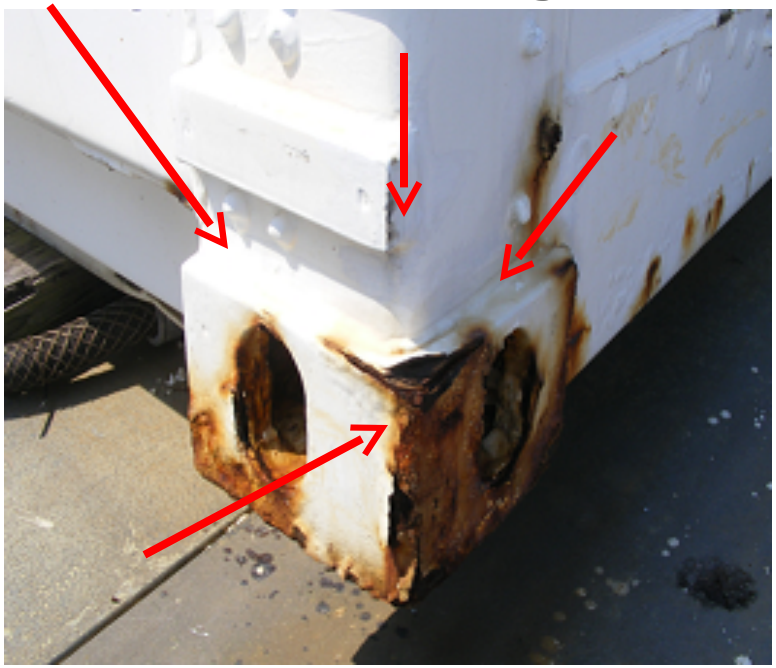
ISO corners delaminating and coliflowering.

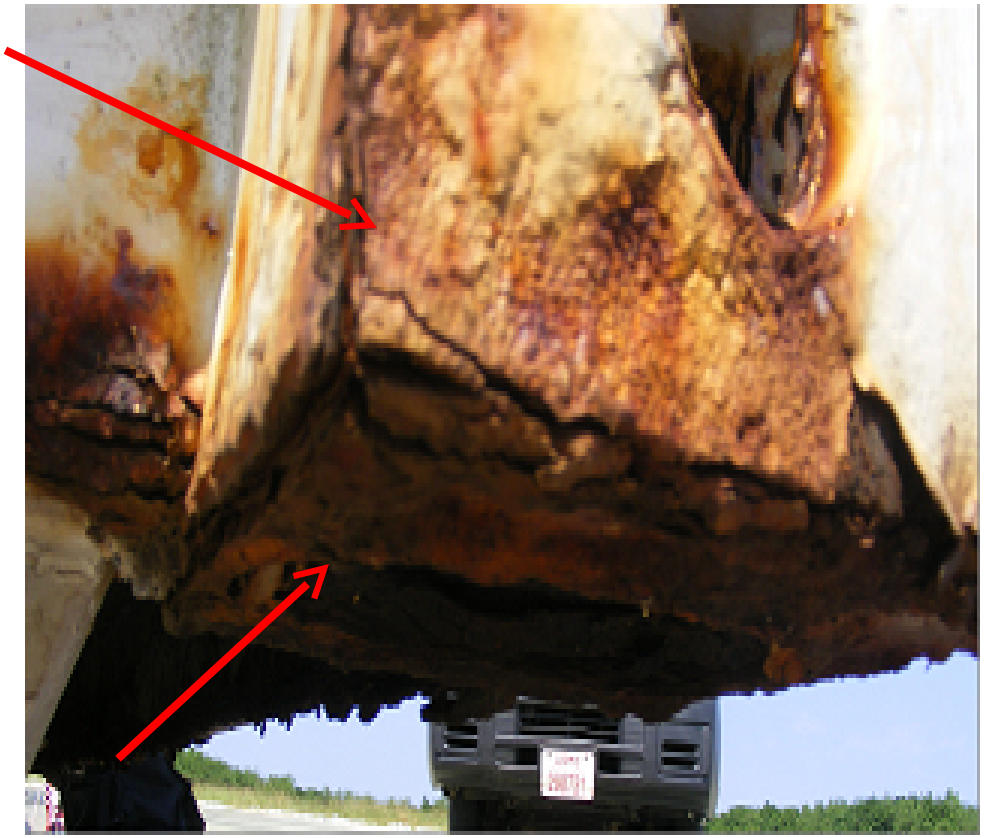
QHR205

ISO corners delaminating and coliflowering.

Bottom side rail damage/deteriorated by corrosion.

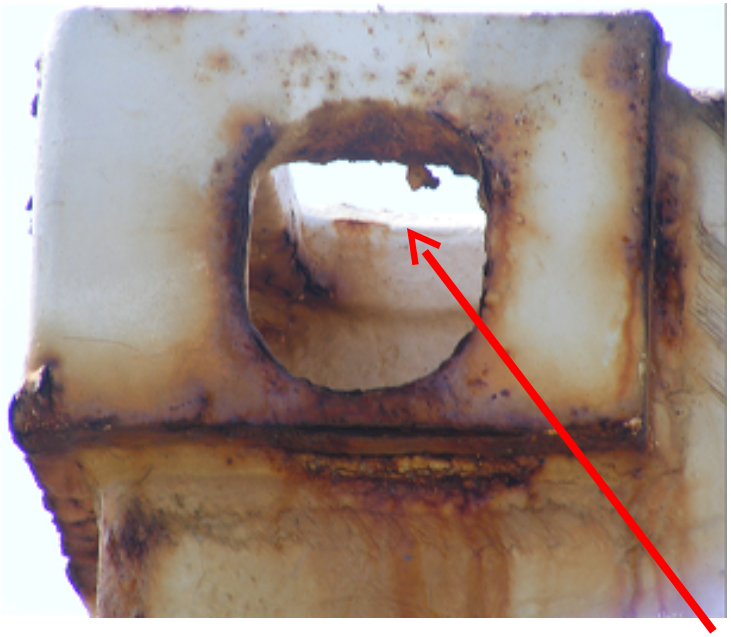
Cracked ISO corner due to corrosion damage.

Forklift pockets deteriorated beyond repair capability. Brittle to the touch.
(All forklift pockets are in the same

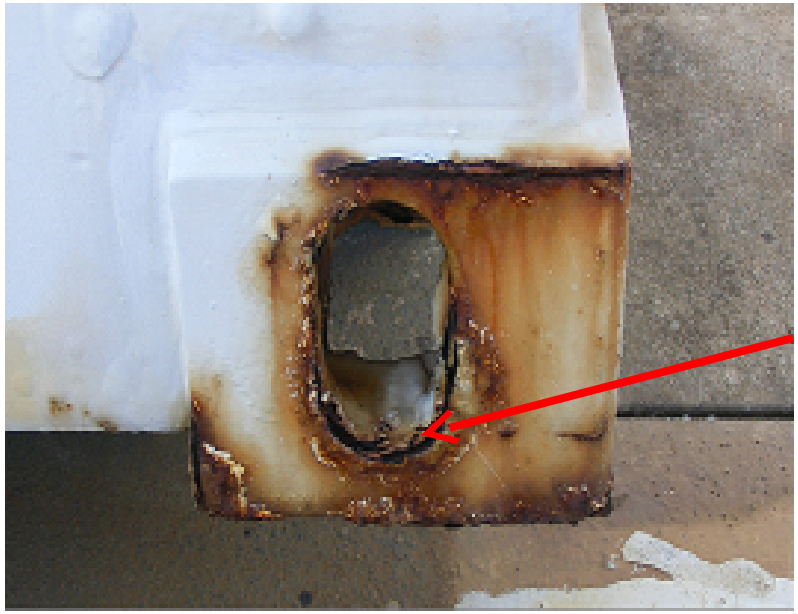
ISO Corner Coliflowering.

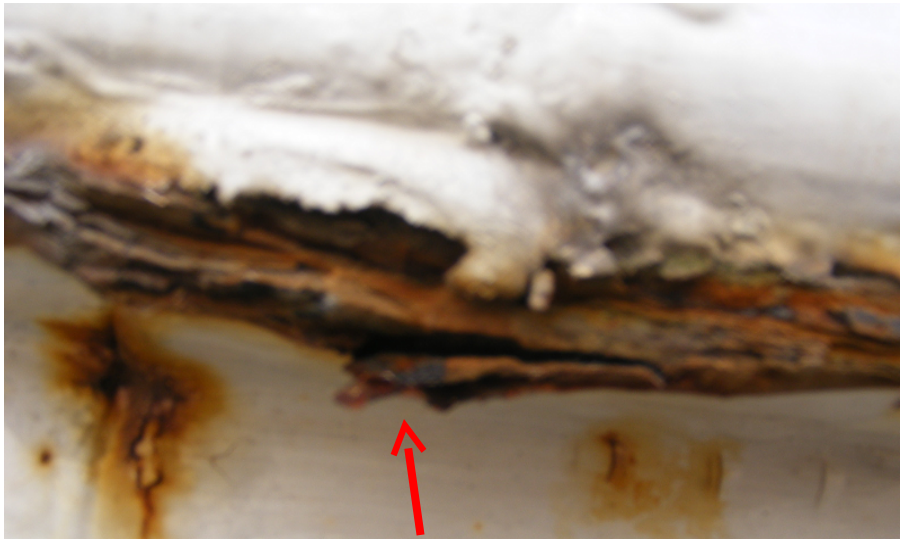
QHR171

Corrosion damage on side rail (structural member).

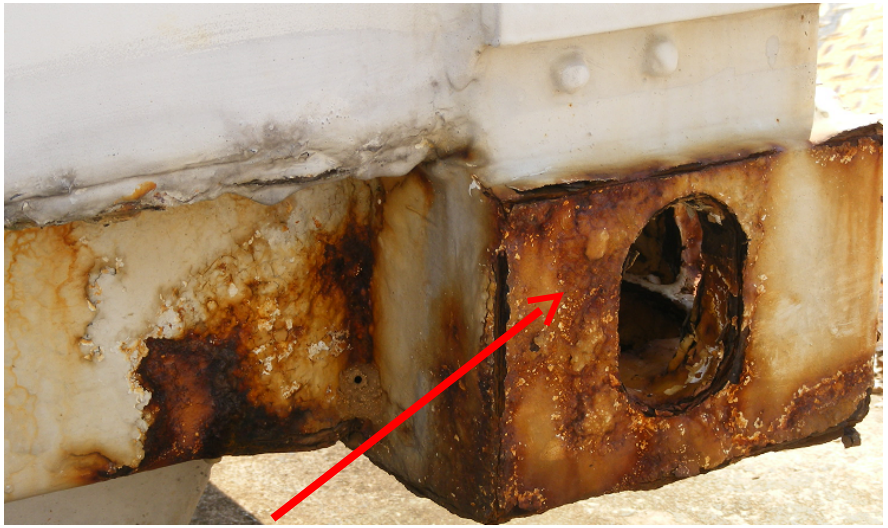
ISO Corner Coliflowering.

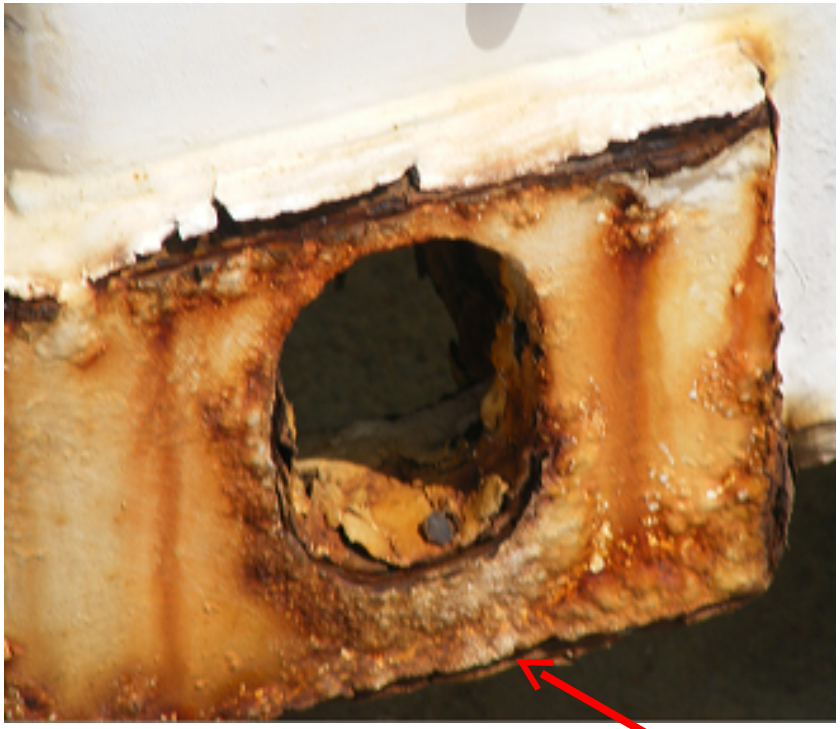
QHR171

ISO Corner Coliflowering.
